POTOMAC CREEK NO. 1

STAFFORD COUNTY, VIRGINIA

VA. NO. 17902

PHASE I INSPECTION REPORT NATIONAL DAM SAFETY PROGRAM

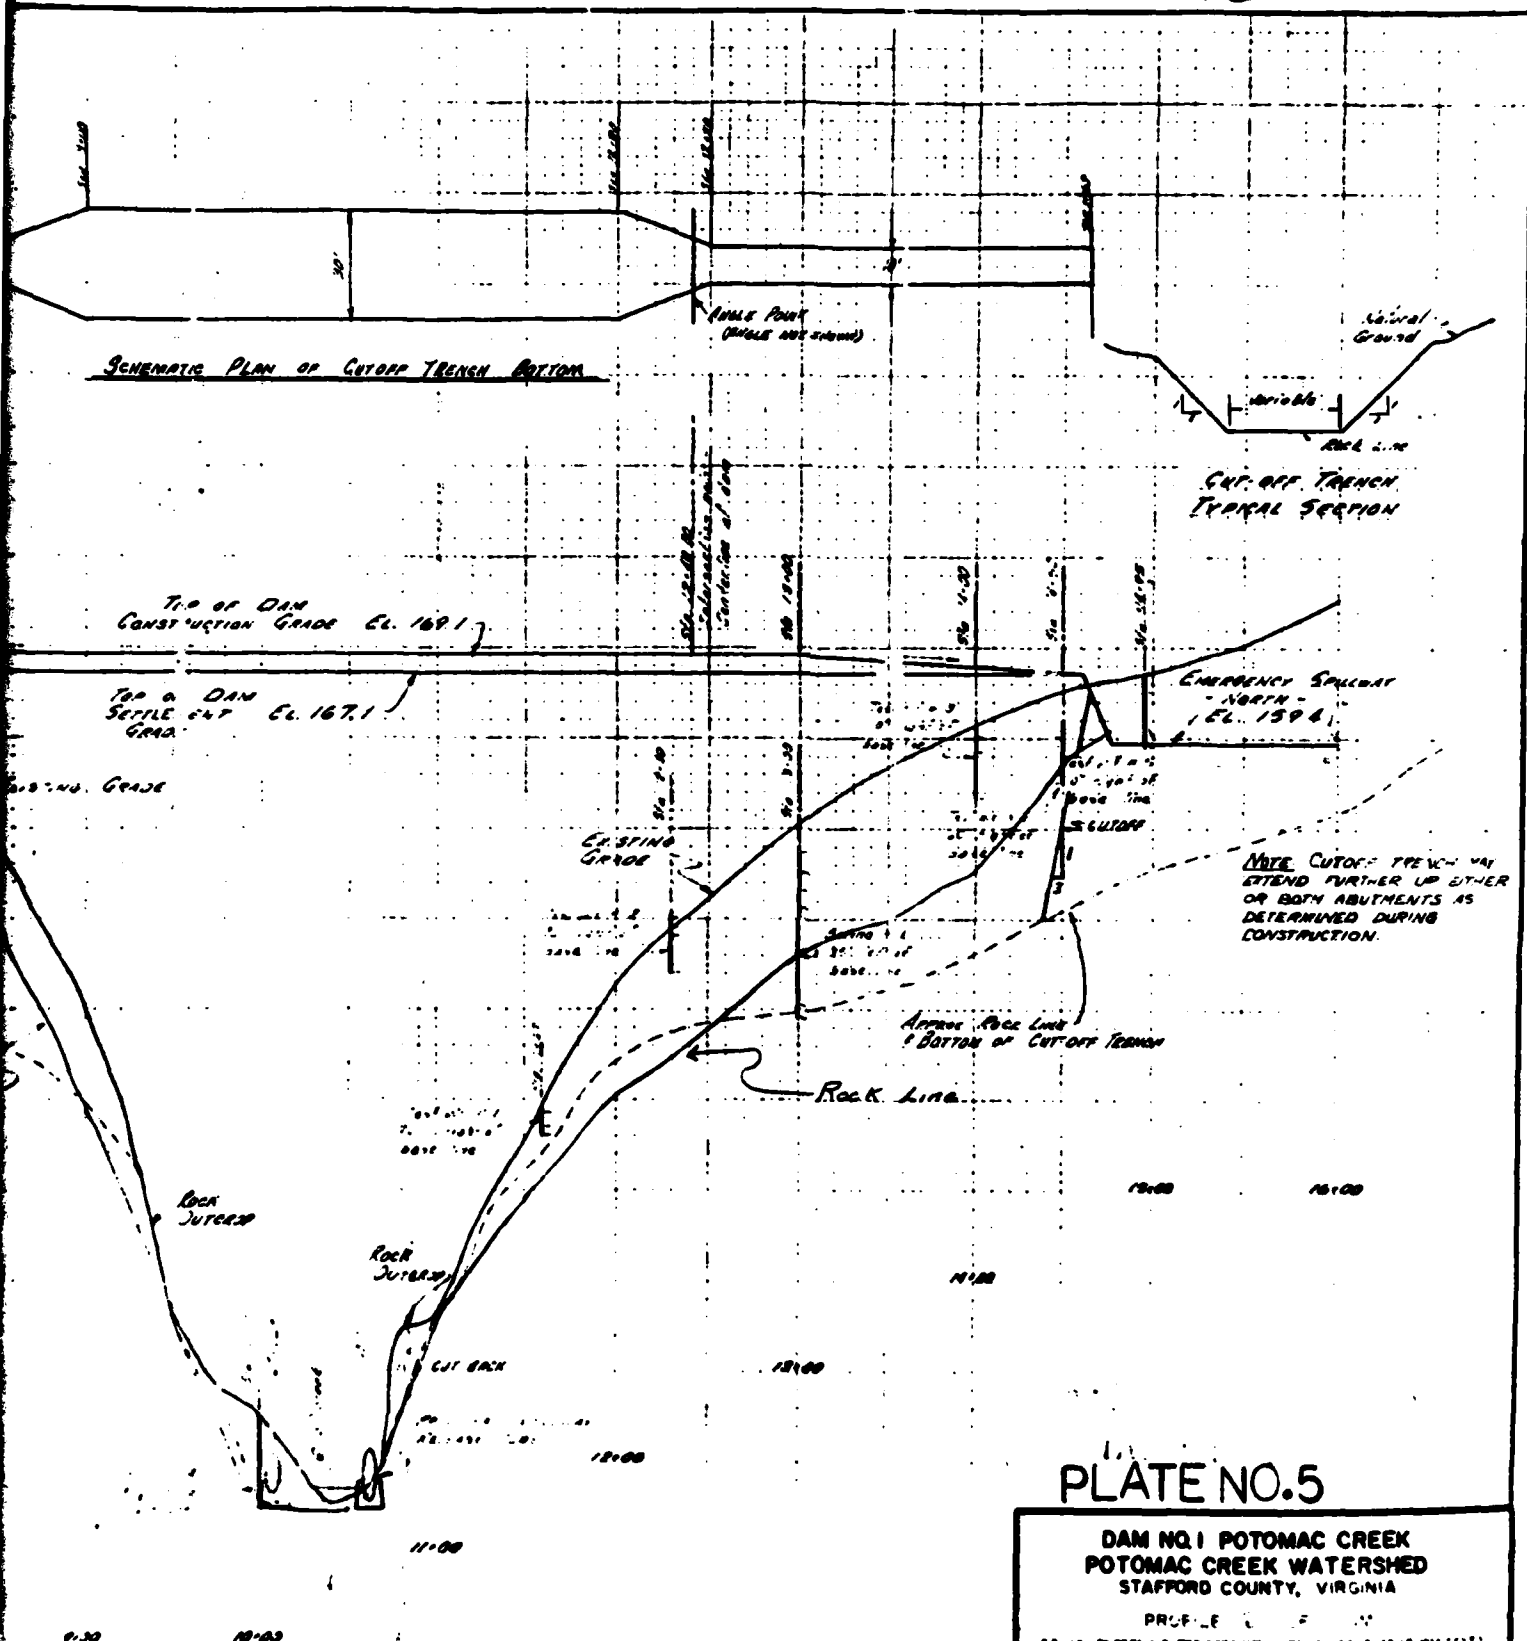
PLATE NO.5

A review of design drawings indicates the dam is founded on overburden and includes a cutoff trench which extends into "firm unweathered rock" (See Plate No. 5, Appendix I). Pressure test data developed in Boring B-1 and B-3 show the overburden materials are susceptible to water loss under pressure. However, water loss was negligible below elevation 120[±] to 115[±] in the unweathered bedrock. The foundation report indicated that the decomposed gneiss underlying the site would be subject to piping, ravelling and erosion in its natural state and possibly in a compacted state.
